Detecting Filter-Cake Pathologies in Solid-Liquid Filtration: Semi-tech Scale Demonstrations Using Electrical Resistance Tomography (ERT)

D. Vlaev¹, M. Wang¹, T. Dyakowski¹, R. Mann¹ and B.D. Grieve²

¹ Department of Chemical Engineering, UMIST, Manchester M60 1QD, UK

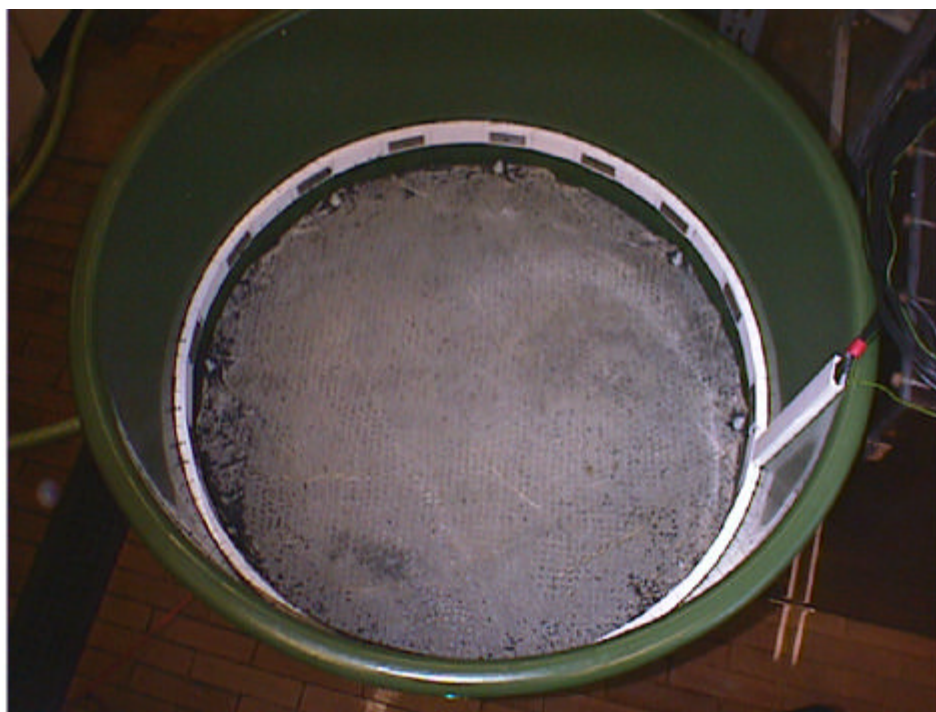
Figure 2 Overhead view of the test filter

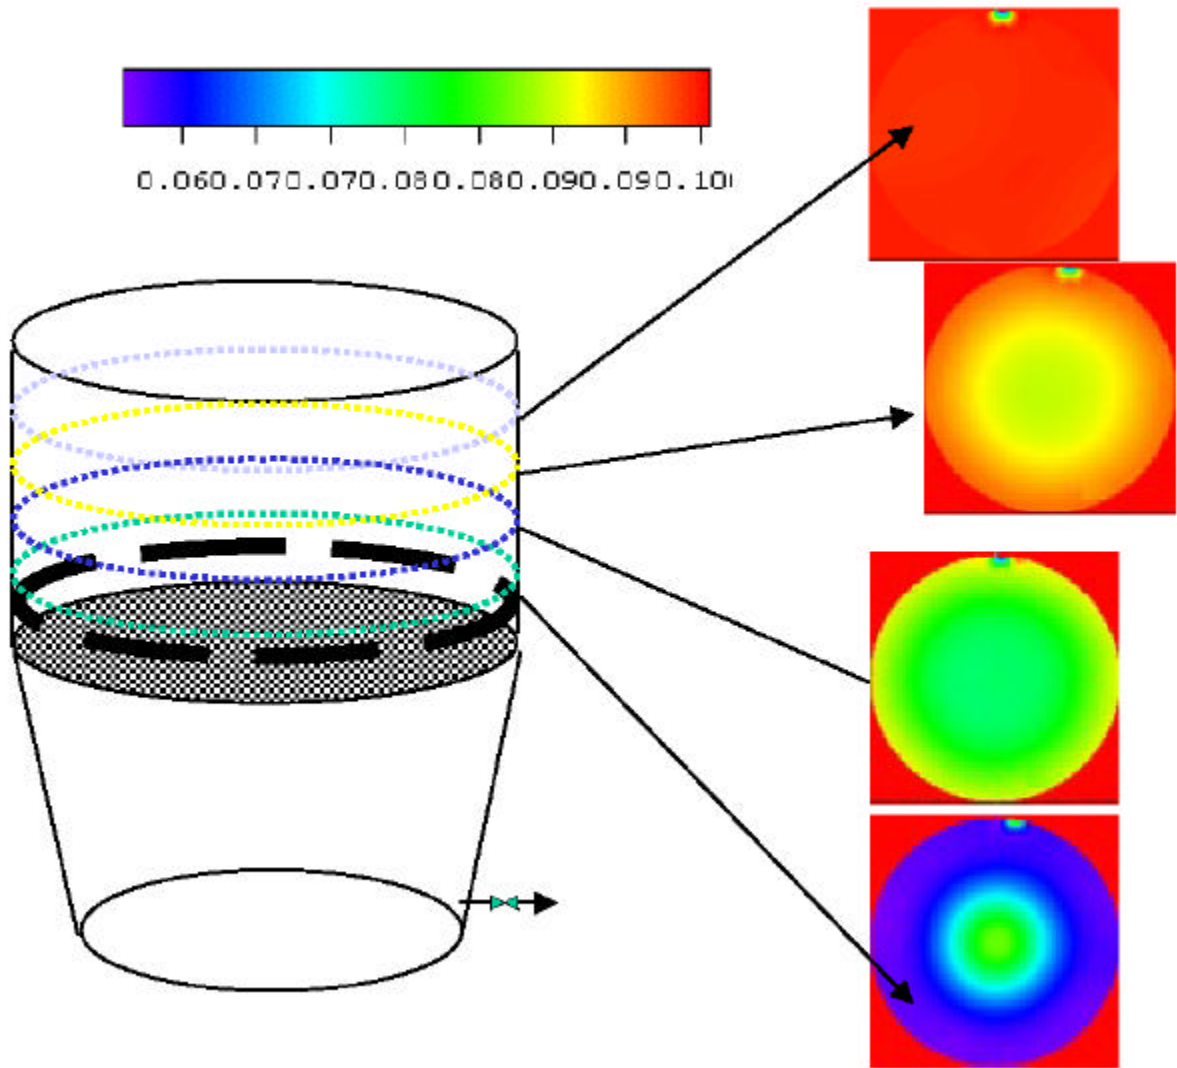
The circumferential ERT sensing array is non-invasive and proved to be capable of remarkable sensitivity in detecting changes in conductivity/resistivity. Unexpectedly, preliminary tests showed clearly that the array could measure resistivity changes accompanying the fall in liquor level above the filter cake and plate. The results are illustrated in Fig. 3. Using an initial zeroing of the sensed resistivity at a starting level of 21 cm above the support plate, the set of resistivities measured and reconstructed by linear back projection produced the tomogram images shown in Fig. 3 for liquor heights of 18, 14 and 7 cm. These cross section views reflect the fact that the resistivity field in 3-D changes as the level of (conducting) fluid descends towards the support plate, so that the filter sensing array becomes a potential liquid level detector. This capability could be extremely

useful in monitoring the progress of filtration. The reconstructed sections are not uniform although they are symmetrical. The non-uniformity is thought to be an artefact caused by the changing 3-D geometry of the resistivity field interacting with the reconstruction technique. Thus some care will be needed in interpreting this effect and additional calibrations will be needed to read-off the actual level in real-time plant operation. Nevertheless, the use of such an ERT array to follow the flow of filtrate/mother liquor presents a new opportunity to improve filtration instrumentation.

Figure 3 Mother liquor level detection during filtration using ERT

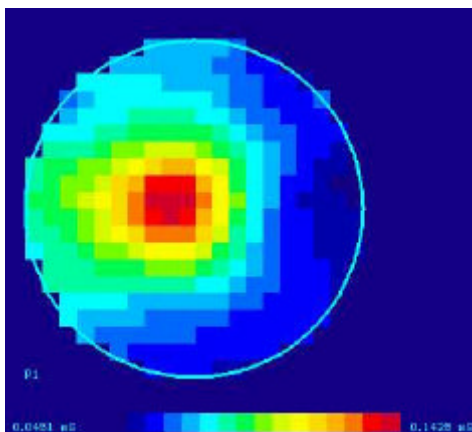
The sensitivity of the ERT array to small changes in local conductivity also provided another unanticipated measurement possibility. If at some point the peripheral sensing array is displaced from the horizontal, the liquid level remains perfectly horizontal but the sensing protocol can detect an imbalance in the set of tomographic measurements. Upon reconstruction by linear back projection, the image can show a clear loss of symmetry as shown in Fig. 4. This sensitivity to tilt could offer a practical possibility for detecting pathologies associated either with initially improper assembly of the support plate/sensor array or alternatively a subsequent accident displacement or malfunction following a proper initial installation. The tomography sensor array can thus provide potential information on correct assembly and on-going mechanical integrity of a filter system.

Figure 4 Tilt detection using ERT
